MASSACHUSETTS COASTAL BASIN  
GLOUCESTER, MASSACHUSETTS

FERNWOOD LAKE DAM  
MA 00184

PHASE I INSPECTION REPORT  
NATIONAL DAM INSPECTION PROGRAM

APRIL, 1979

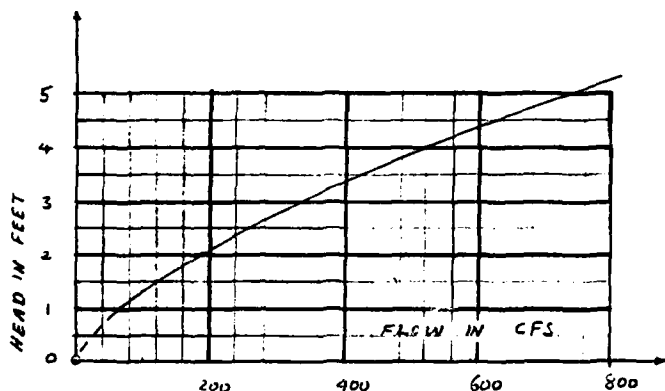
HEAD - CAPACITY CURVE - SPILLWAY

About 150 cfs of the total would flow over the spillway, which would require a head of 1.7-ft as can be seen in the curve below;  $93.9 - 92.3 = 1.6 \text{ -ft} \approx 1.7 \text{ ft}$ . The remaining 220 cfs would flow over the East and South dams.

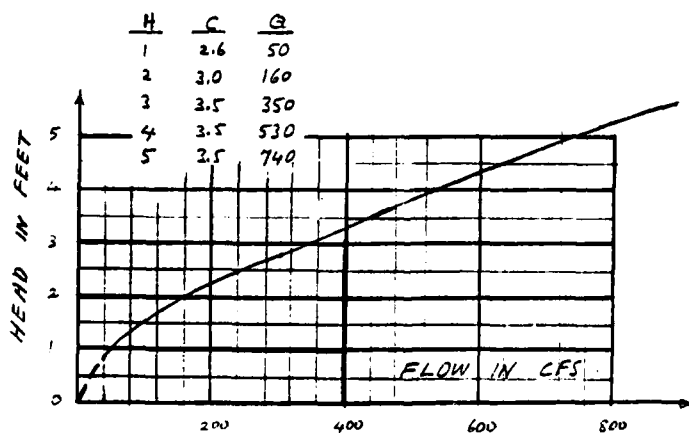
HEAD-CAPACITY CURVE  
 SPILLWAY  
 (No Flashboards)

The spillway head-capacity curve for this condition would be somewhat different because of the crest shape; 160 cfs would flow over the spillway and the remaining 140 cfs over the east and south drains - The required head at the spillway: 1.8 ~ 2.0 feet.

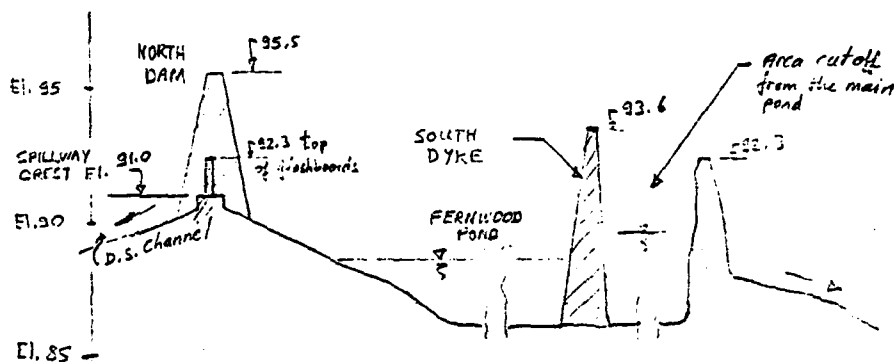
Any flow overtopping the South dyke ~~would~~ would fill the cutoff portion of the pond at the southern tip and then overflow into a swampy area which has a channel outlet to the Wallace pond. A schematic cross section of the pond is shown below:

Conclusion: The spillway is adequate for the test flood whether the existing 1.3-foot high flashboards are left in place or not. However the South dyke and the East dam would be overtopped by about 0.2 and 0.4 feet, respectively.

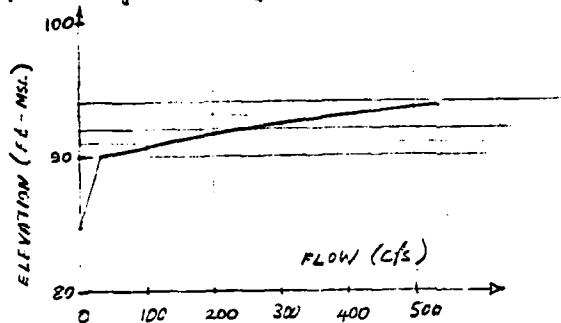
STAGE - DISCHARGE CURVE @ DRIVEWAY CULVERT

<u>E1.</u>
$Q_1 = 100 \text{ cfs} \rightarrow \Delta Q = 60 \text{ cfs} \rightarrow H_1 = 0.85 \text{ -ft}$		90.25
$Q_2 = 200 \text{ cfs} \rightarrow \Delta Q = 160 \text{ " } \rightarrow H_2 = 1.65 \text{ -ft}$		91.65
$Q_3 = 300 \text{ cfs} \rightarrow \Delta Q = 260 \text{ " } \rightarrow H_3 = 2.30 \text{ -ft}$		92.30
$Q_4 = 500 \text{ cfs} \rightarrow \Delta Q = 460 \text{ " } \rightarrow H_4 = 3.55$		93.55
